AVIATION INVESTIGATION REPORT

A03C0094

LOSS OF PITCH CONTROL AND COLLISION WITH TERRAIN

BEECH 99A C-FDYF

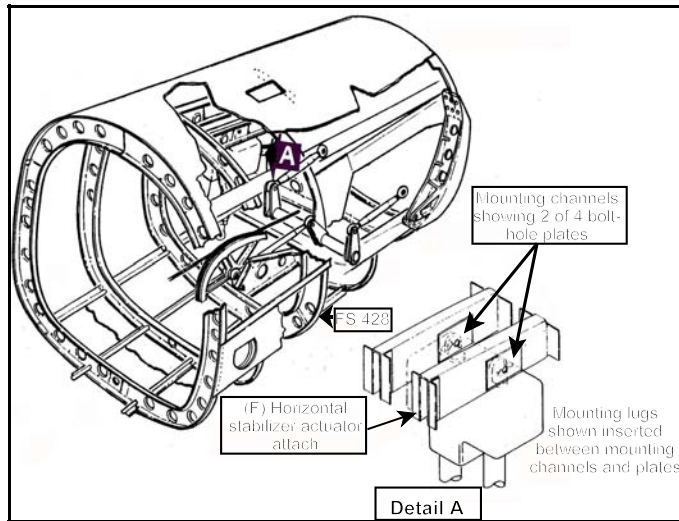
Figure 1. Horizontal stabilizer trim actuator mount structure

The airframe mounting structure for the horizontal stabilizer trim actuator consists of four channel-and-plate assemblies that are aligned fore-and-aft and installed between a former, located at station 418.900, and a bulkhead located at station 428.335, in the upper section of the aircraft tail. To provide a bolt hole through which close-tolerance mounting bolts are installed, a plate is rivetted to each channel. There are two upper mounting lugs on the horizontal stabilizer trim actuator; both mounting lugs include a spherical bearing. To attach the trim actuator to the upper airframe structure, a separate high-tolerance bolt is installed through the holes in each set of paired channels and through the spherical bearing for each of the mounting lugs. The installer is on his knees, leaned forward and holding the actuator (approximately 10 pounds) in place, above and ahead. The mounting lugs are hidden from view between their respective

channels and the bolts are installed by feel. At any time in the process, the spherical bearings may rotate slightly, making it difficult to insert the close-tolerance bolts. The normal procedure is to insert a bolt through one of the channel pairs and the mounting lug, suspending the weight of the actuator from the airframe mounting structure (see Figures 1 and 2).

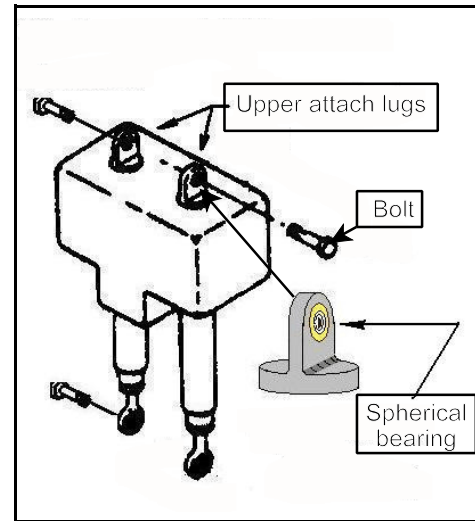
Figure 2. Horizontal stabilizer trim actuator

With the trim actuator installed between the airframe mounting channels, the area behind the mounting lugs is hidden from view. When viewed from the front, the heads and nuts of the bolts line up outside the channels, but it is difficult to assess whether the bolts pass through or behind the lugs. When the bolts have been installed, the mounting lugs are hidden behind the channel assemblies. There are no alignment marks on the sides of the actuator or on the airframe channels to identify the correct positioning of the actuator.

During installation of the trim actuator, the installer is in an awkward position and is holding the relatively heavy actuator in place and ahead of him. The mounting lugs are hidden from view from the side by the mounting channels and hidden from the front by the body of the actuator, so the bolts are installed by feel. If the actuator is moved rearwards and against the bulkhead, the bolts cannot be inserted. However, the mounting lugs can be positioned far

enough forward that the bolts may be inserted behind rather than through the lugs. The installer might expect that the actuator would simply fall free if the bolts were not correctly installed. However, as in this instance, the mounting lug assemblies can become jammed between rivets and the mounting bolts. The weight of the actuator is suspended leading the installer to believe that the bolts have been successfully installed.

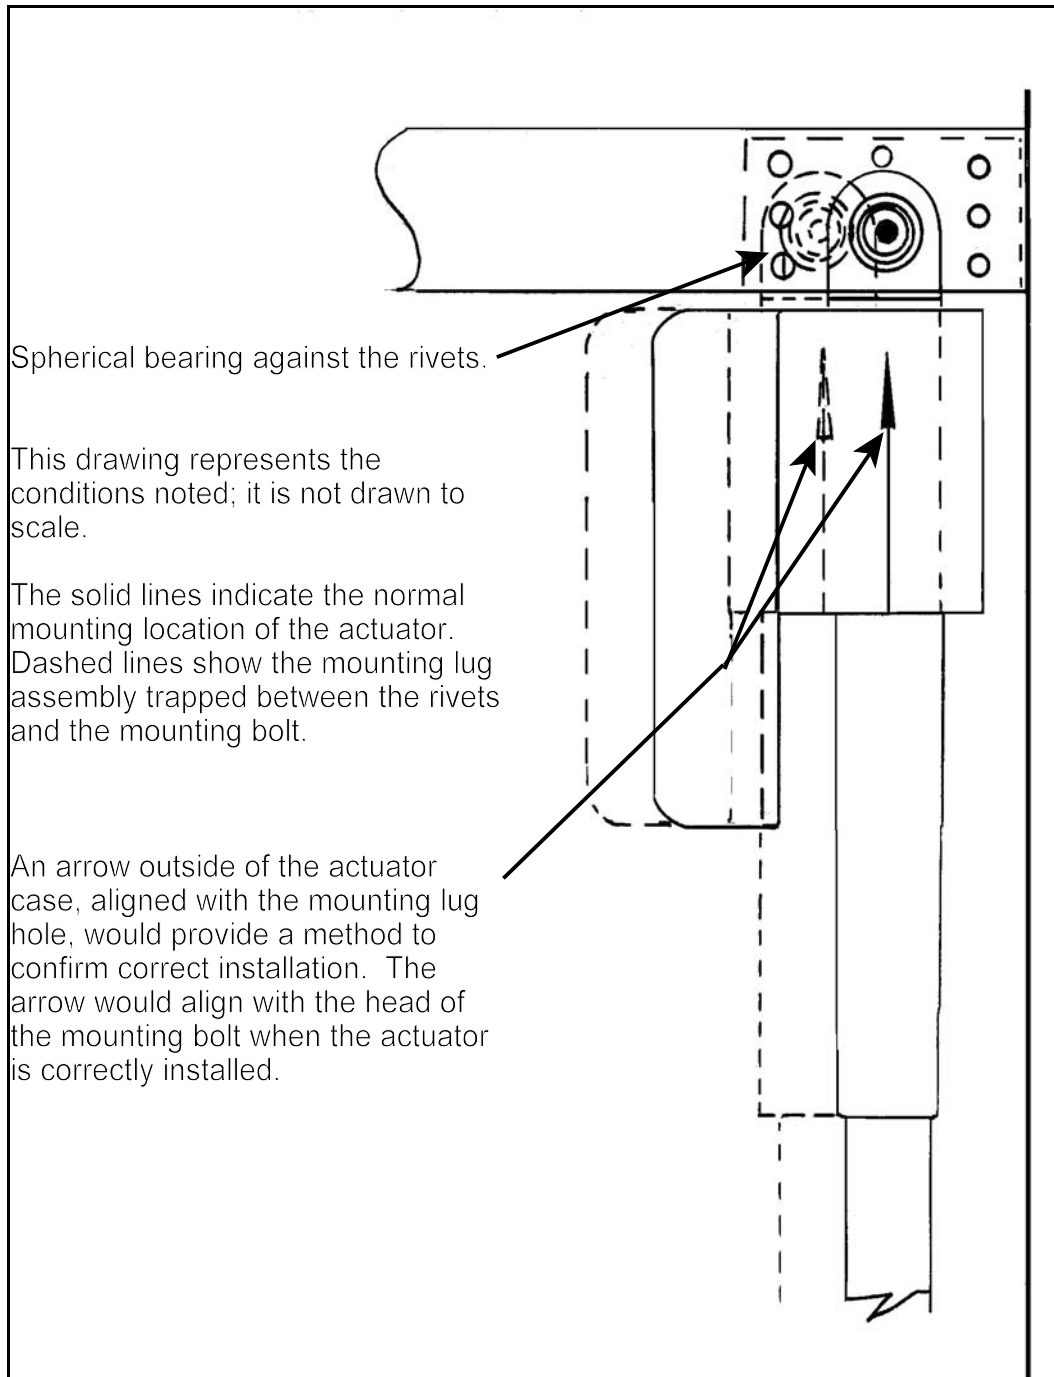
Appendix A – Representative Drawing of Actuator Installation

After the accident, inspection of the horizontal stabilizer trim control system revealed that the stabilizer trim actuator had fallen from the upper airframe mounting structure, allowing the stabilizer to move freely in flight. The mounting bolts had been installed through the airframe brackets but not through the mounting lugs of the trim actuator. Contact marks on the mounting lug assemblies, marks on the channel and plate assemblies, and worn rivets indicated that the upper mounting lugs had been positioned ahead of the normal mounting location. Placed in this manner, the spherical bearings of the lugs were positioned slightly above and in contact with the plate-to-channel attachment rivets. Marks on the rear of each mounting lug confirmed that the mounting bolts were installed behind the mounting lugs, trapping the mounting lug assemblies between the rivets and the bolt shanks. Positioned in this manner, the mounting lugs are approximately $\frac{3}{4}$ inch ahead of their appropriate location (see Appendix A).
